Rachel Rosoff Fatality At Heritage Point Pool

John Cavaroc, Ph.D., P.E.

3-2-2023

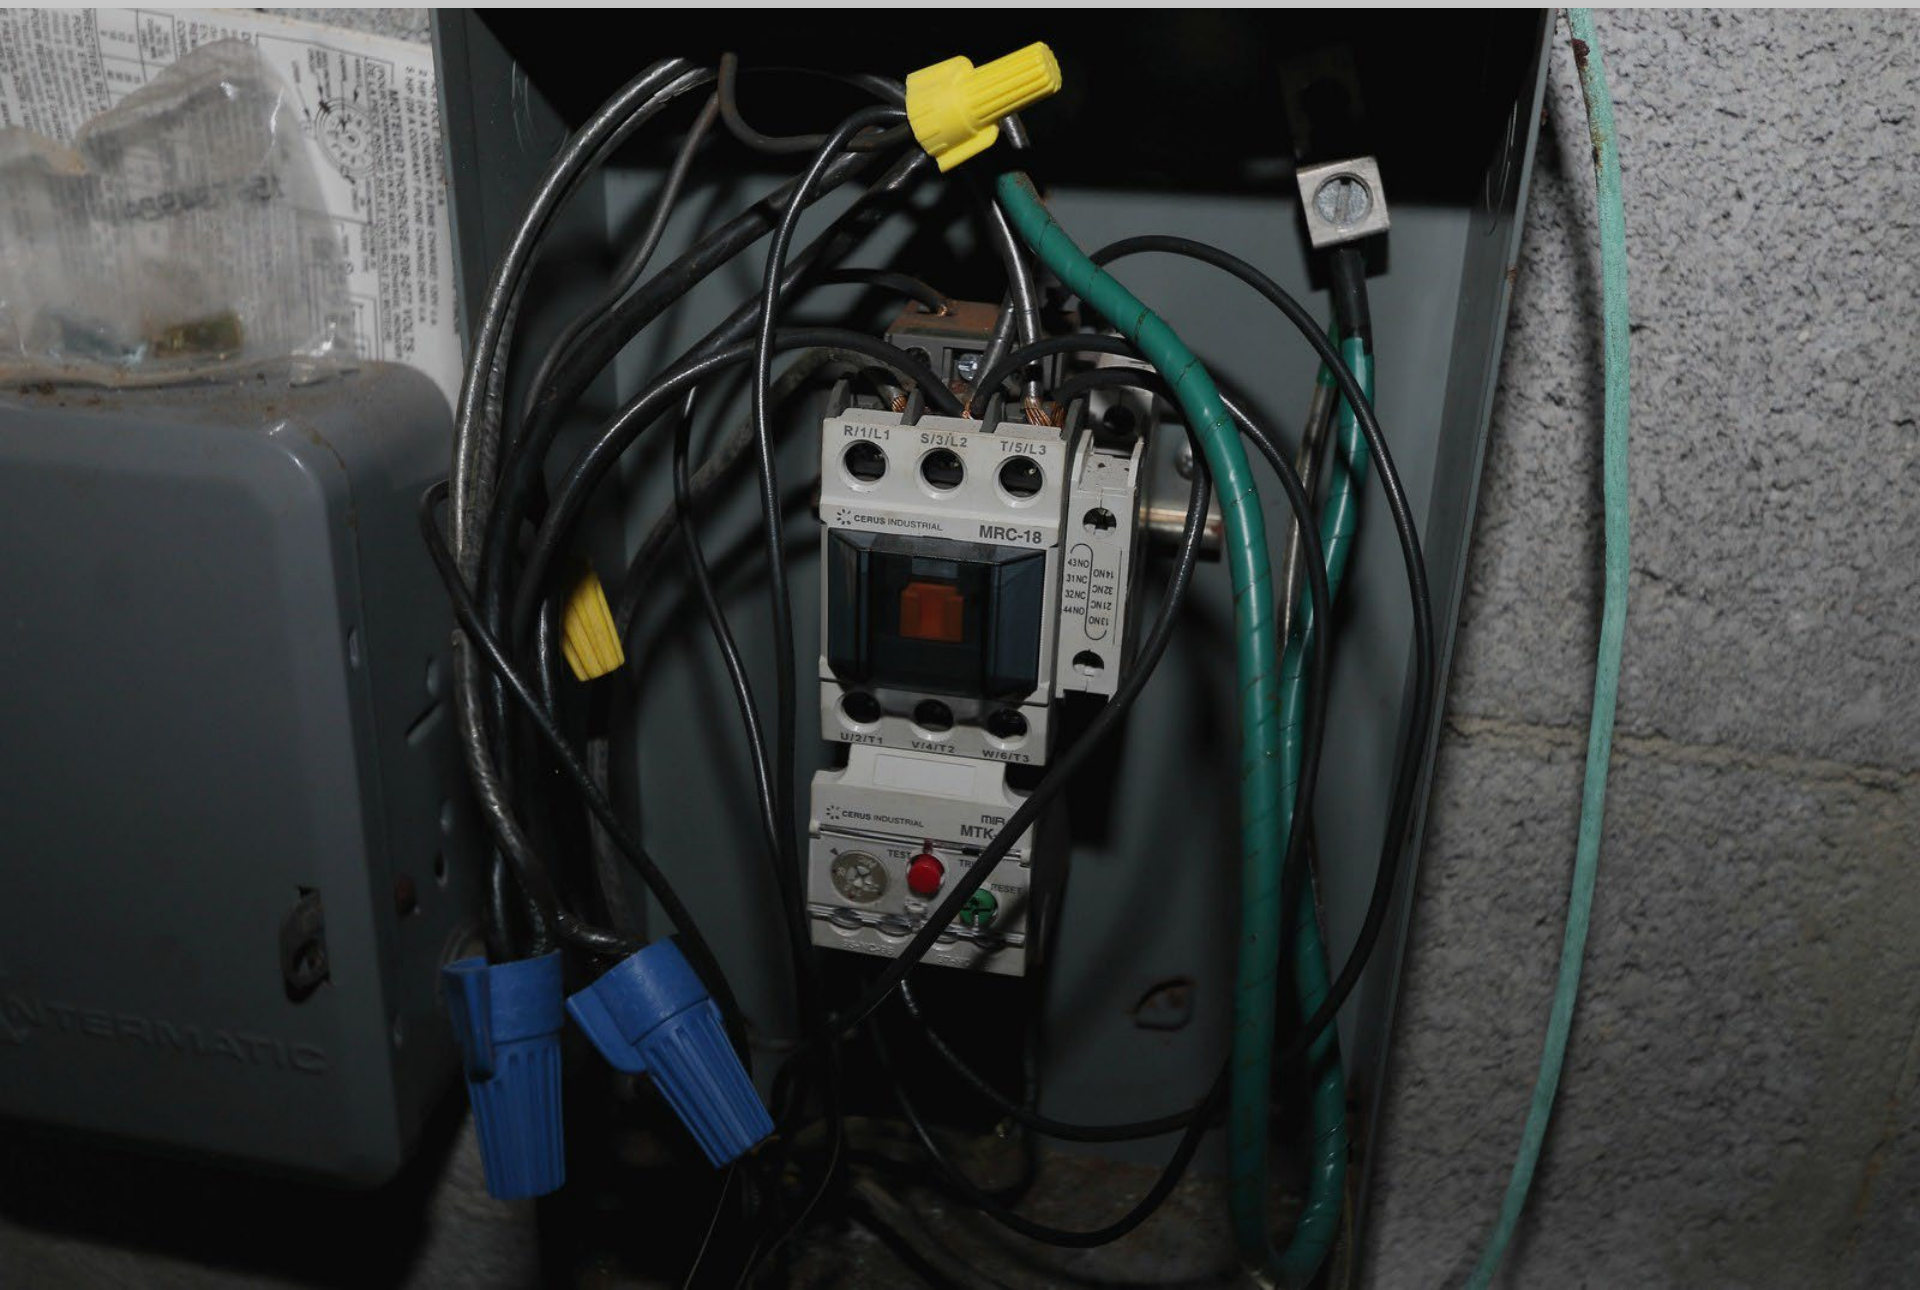
R/1/L1 S/3/L2 T/5/L3
CERUS INDUSTRIAL MRC-18
43 NO ON V1
31 NC ON Z2
32 NC ON L2
44 NO ON E1
U/2/T1 V/4/T2 W/6/T3

Section	Description
110.3 (B)	motor starter installed in 2010 incorrect size, should be MRC32A
110.3 (B)	pump house - 50uF capacitor replaced with 30uF capacitor

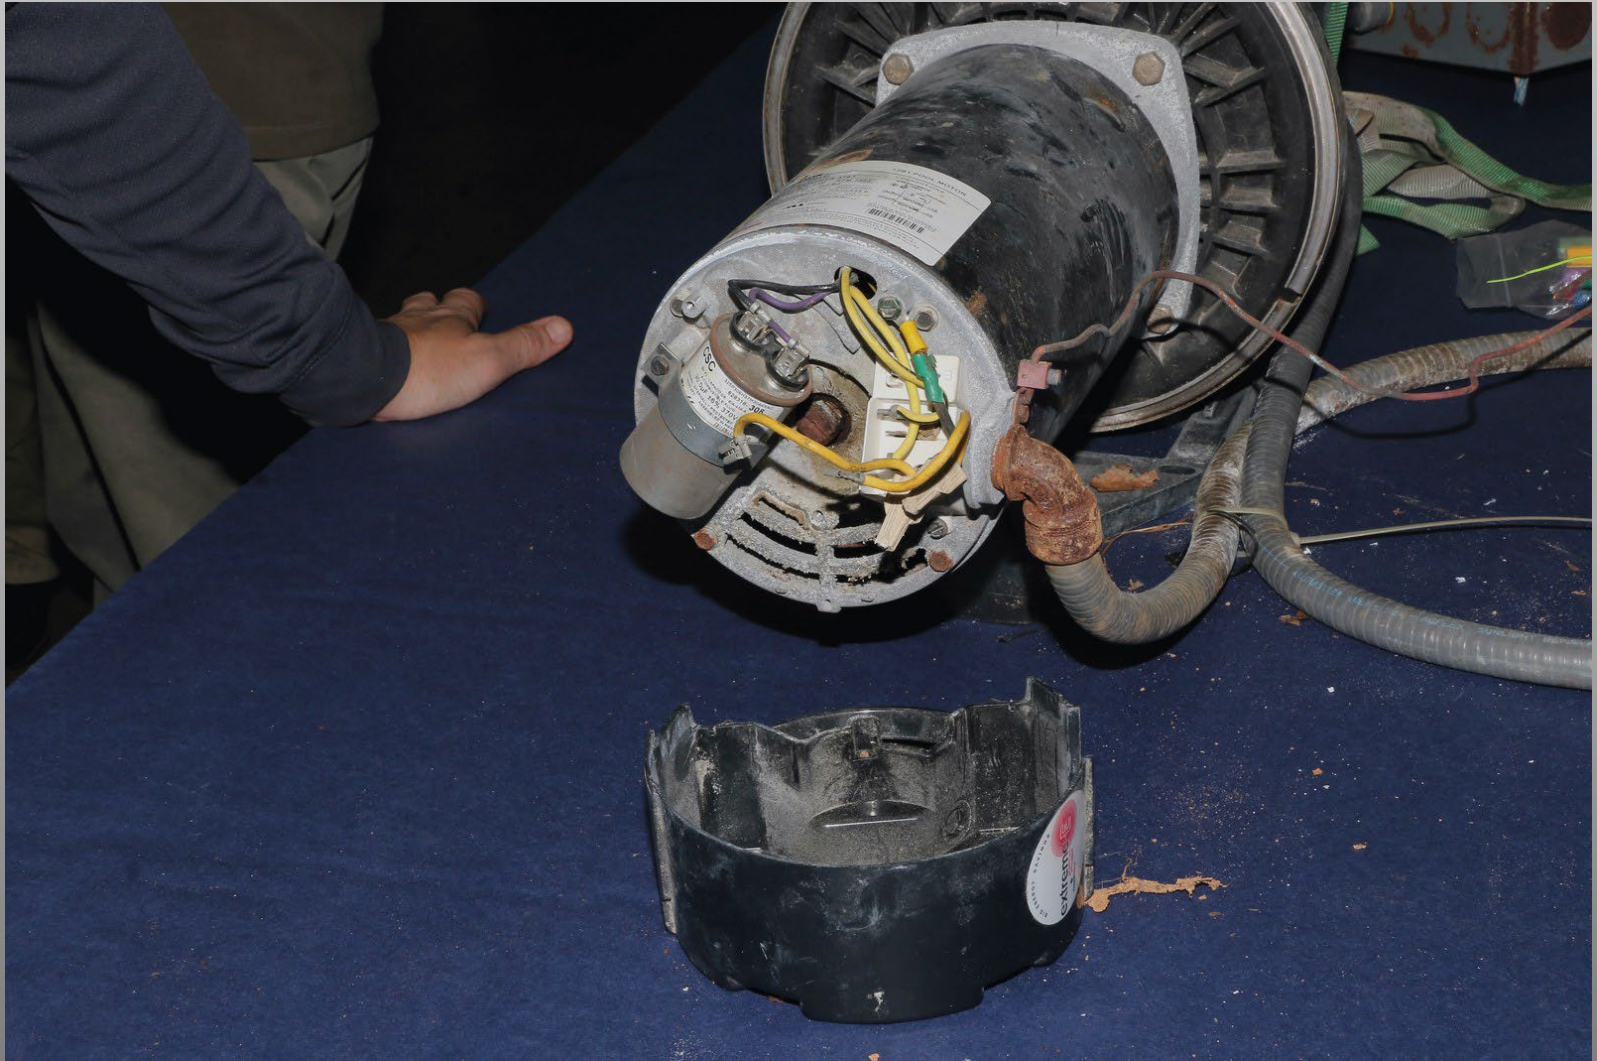
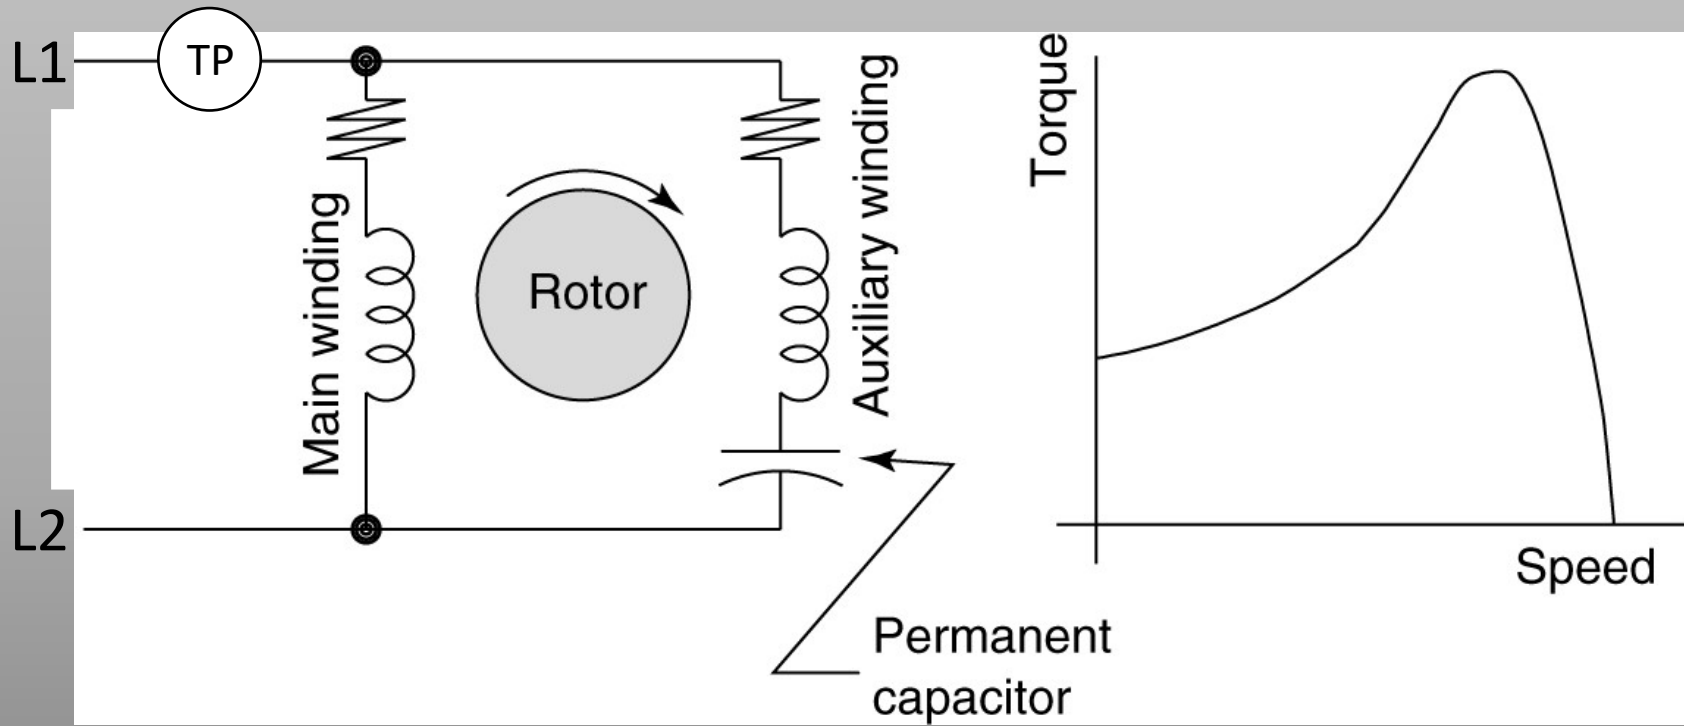
L1 to L2	Open
L1 to GND	Open
L2 to GND	0.522 Ω

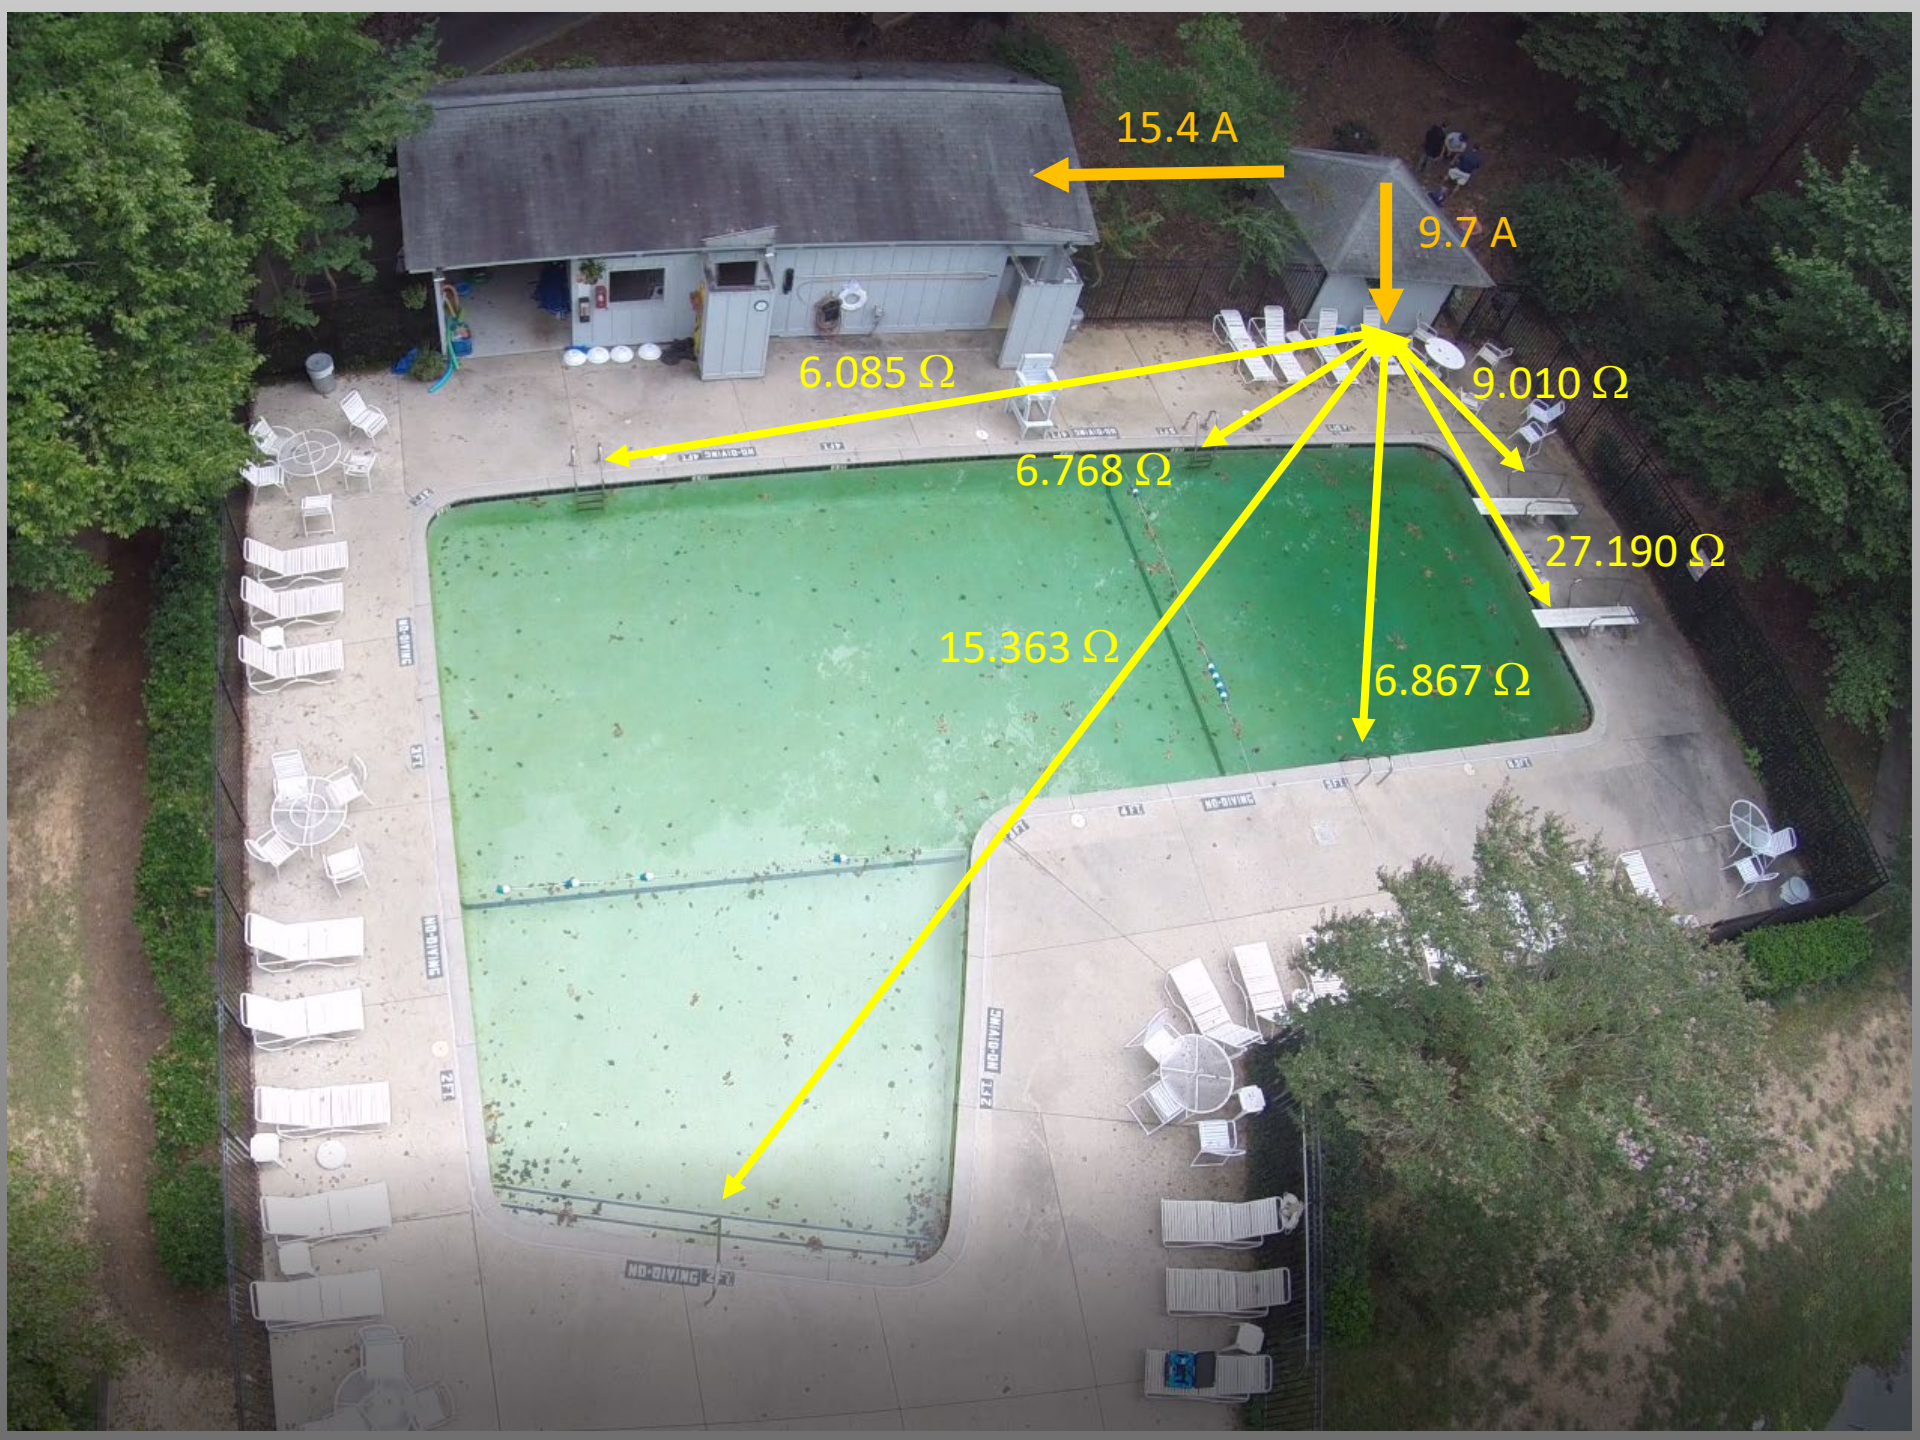
15.4 A

9.7 A

6.085 Ω

9.010 Ω

6.768 Ω

27.190 Ω

15.363 Ω

6.867 Ω

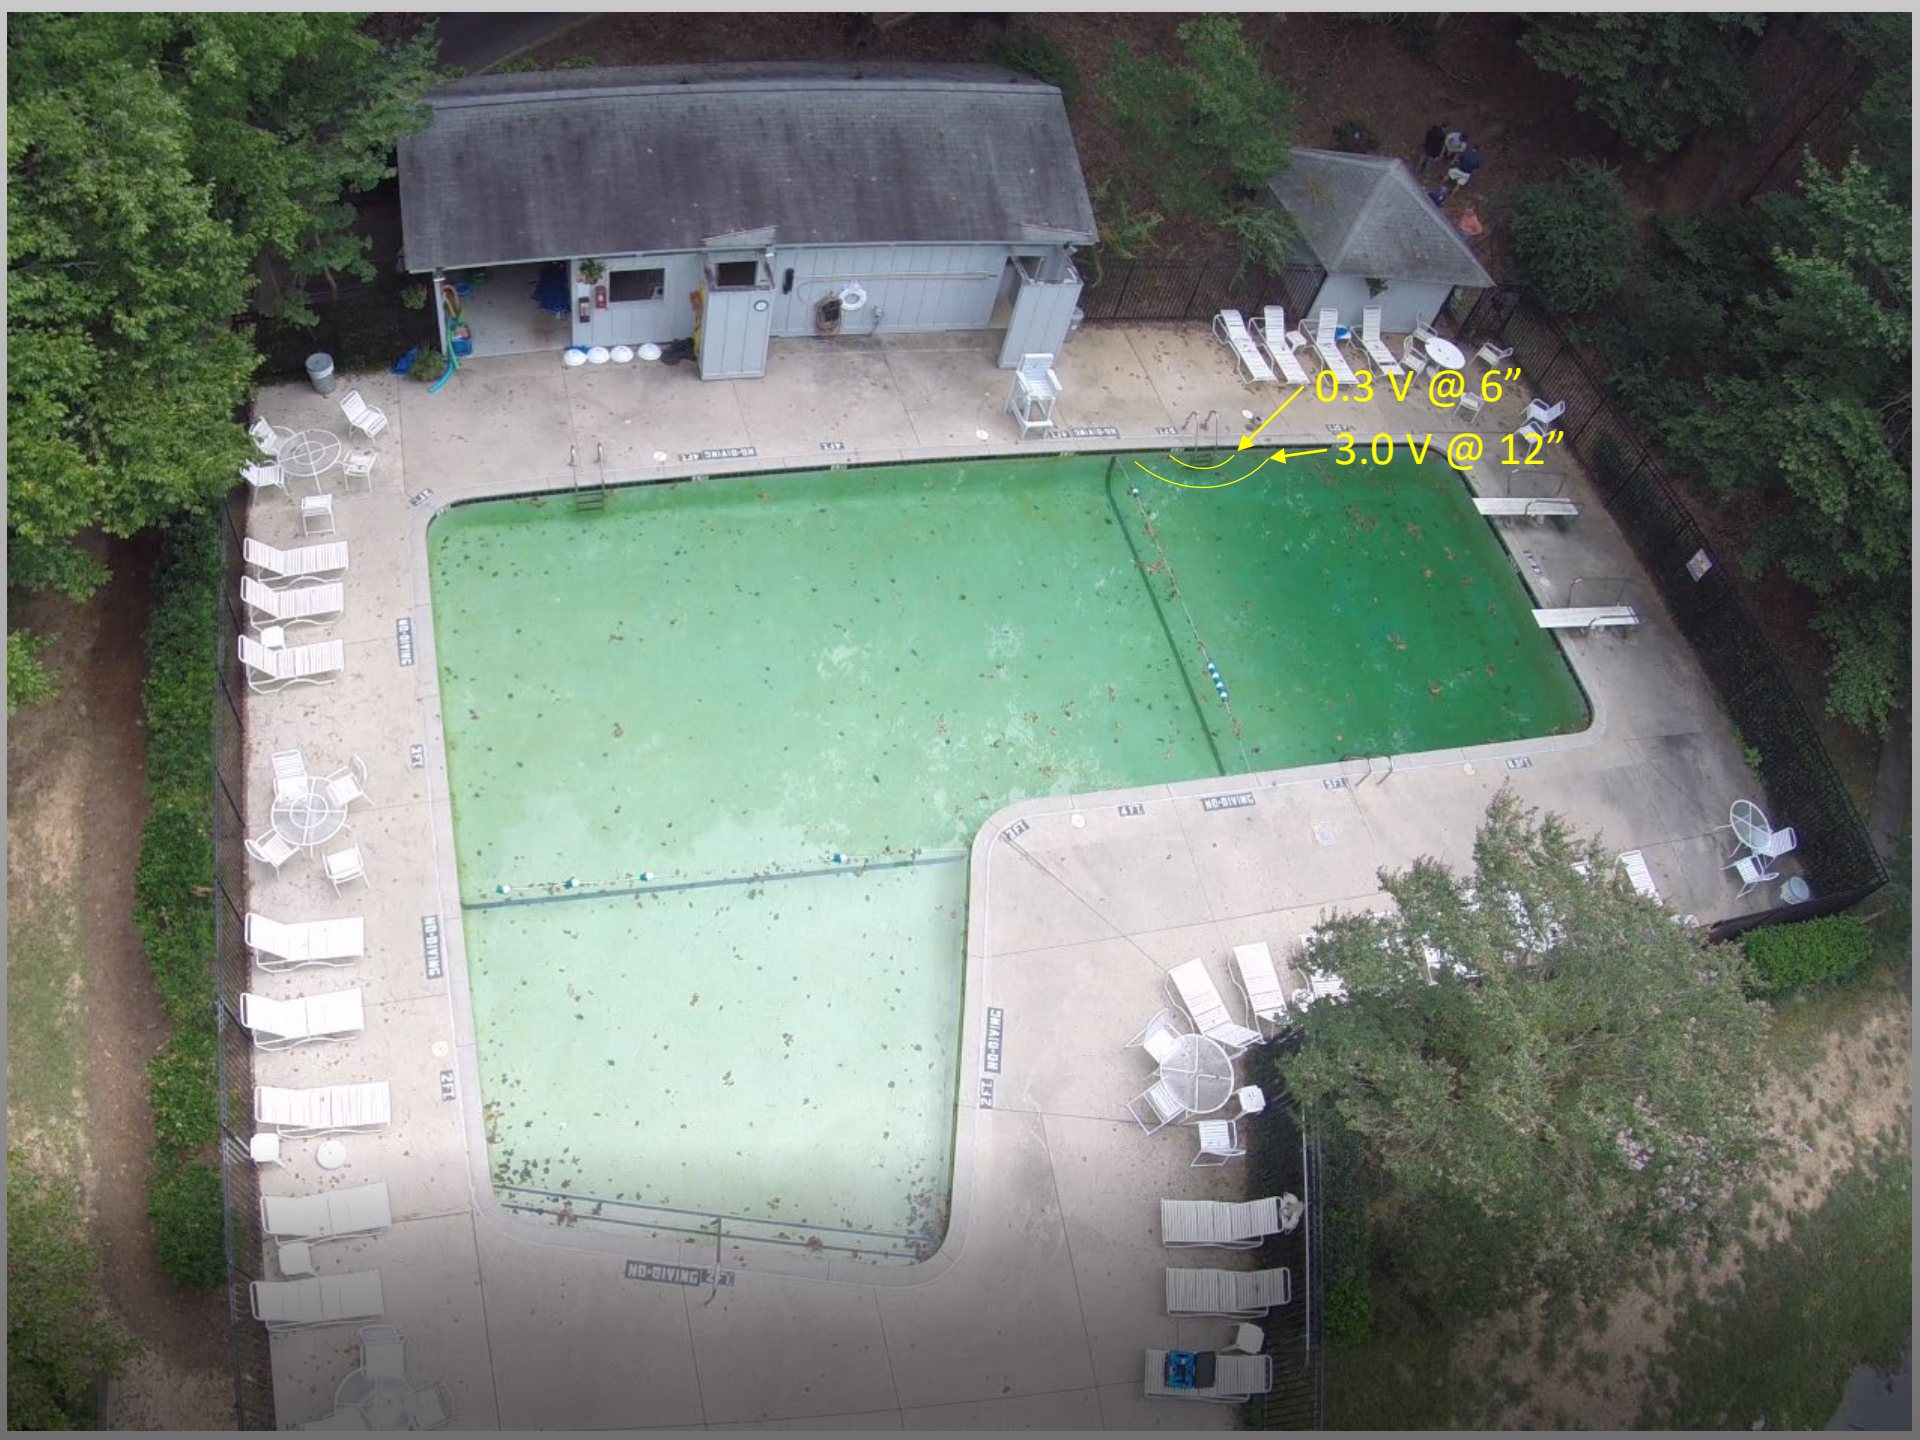
0.3 V @ 6"
3.0 V @ 12"
