Rachel Rosoff Fatality At Heritage Point Pool

John Cavaroc, Ph.D., P.E.

3-2-2023

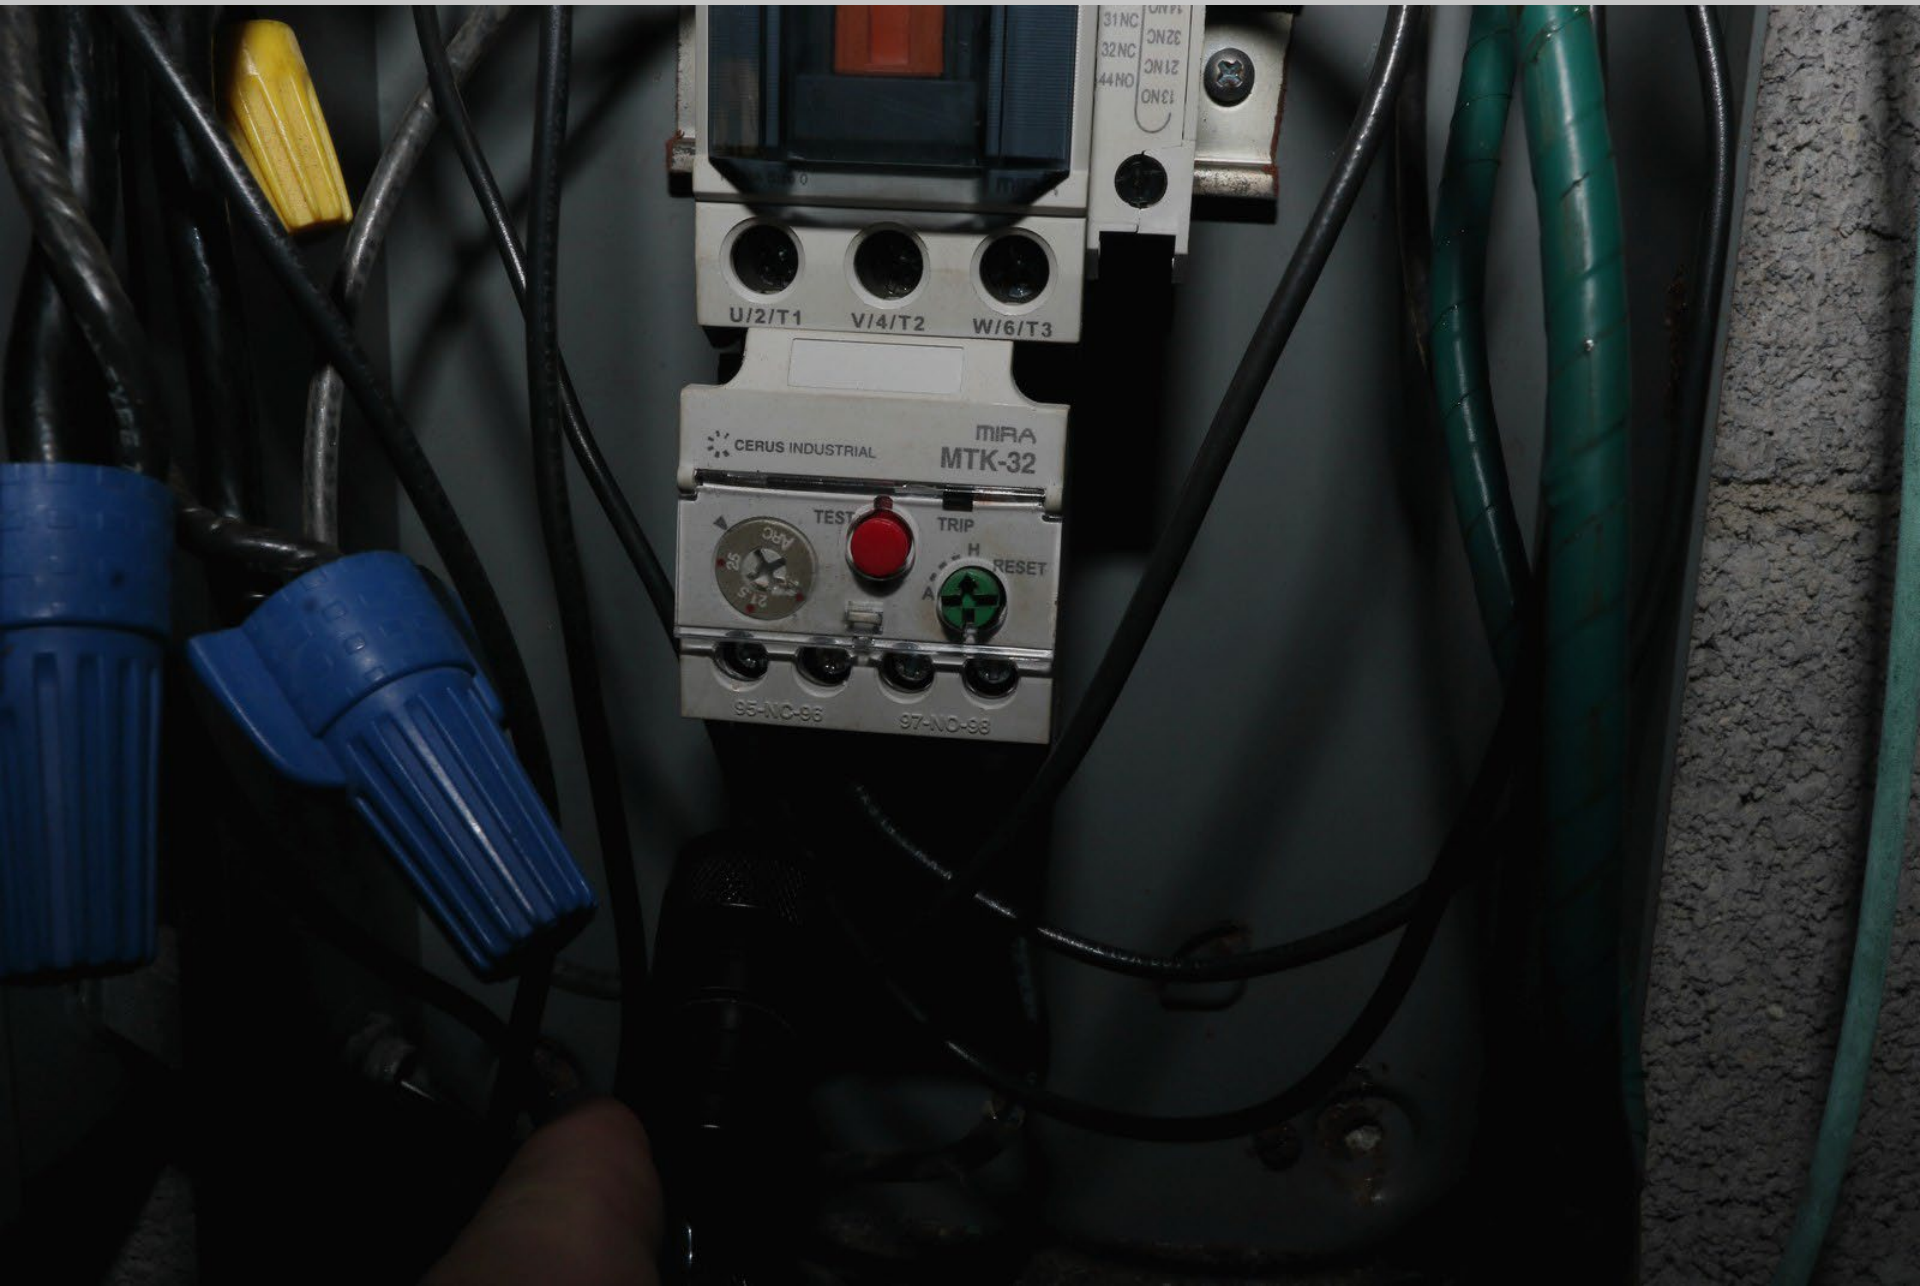
R/1/L1 S/3/L2 T/5/L3
CERUS INDUSTRIAL MRC-18
43 NO ON V1
31 NC ON Z2
32 NC ON L2
44 NO ON E1
U/2/T1 V/4/T2 W/6/T3

CERUS INDUSTRIAL MTK
TEST TRIP RESET

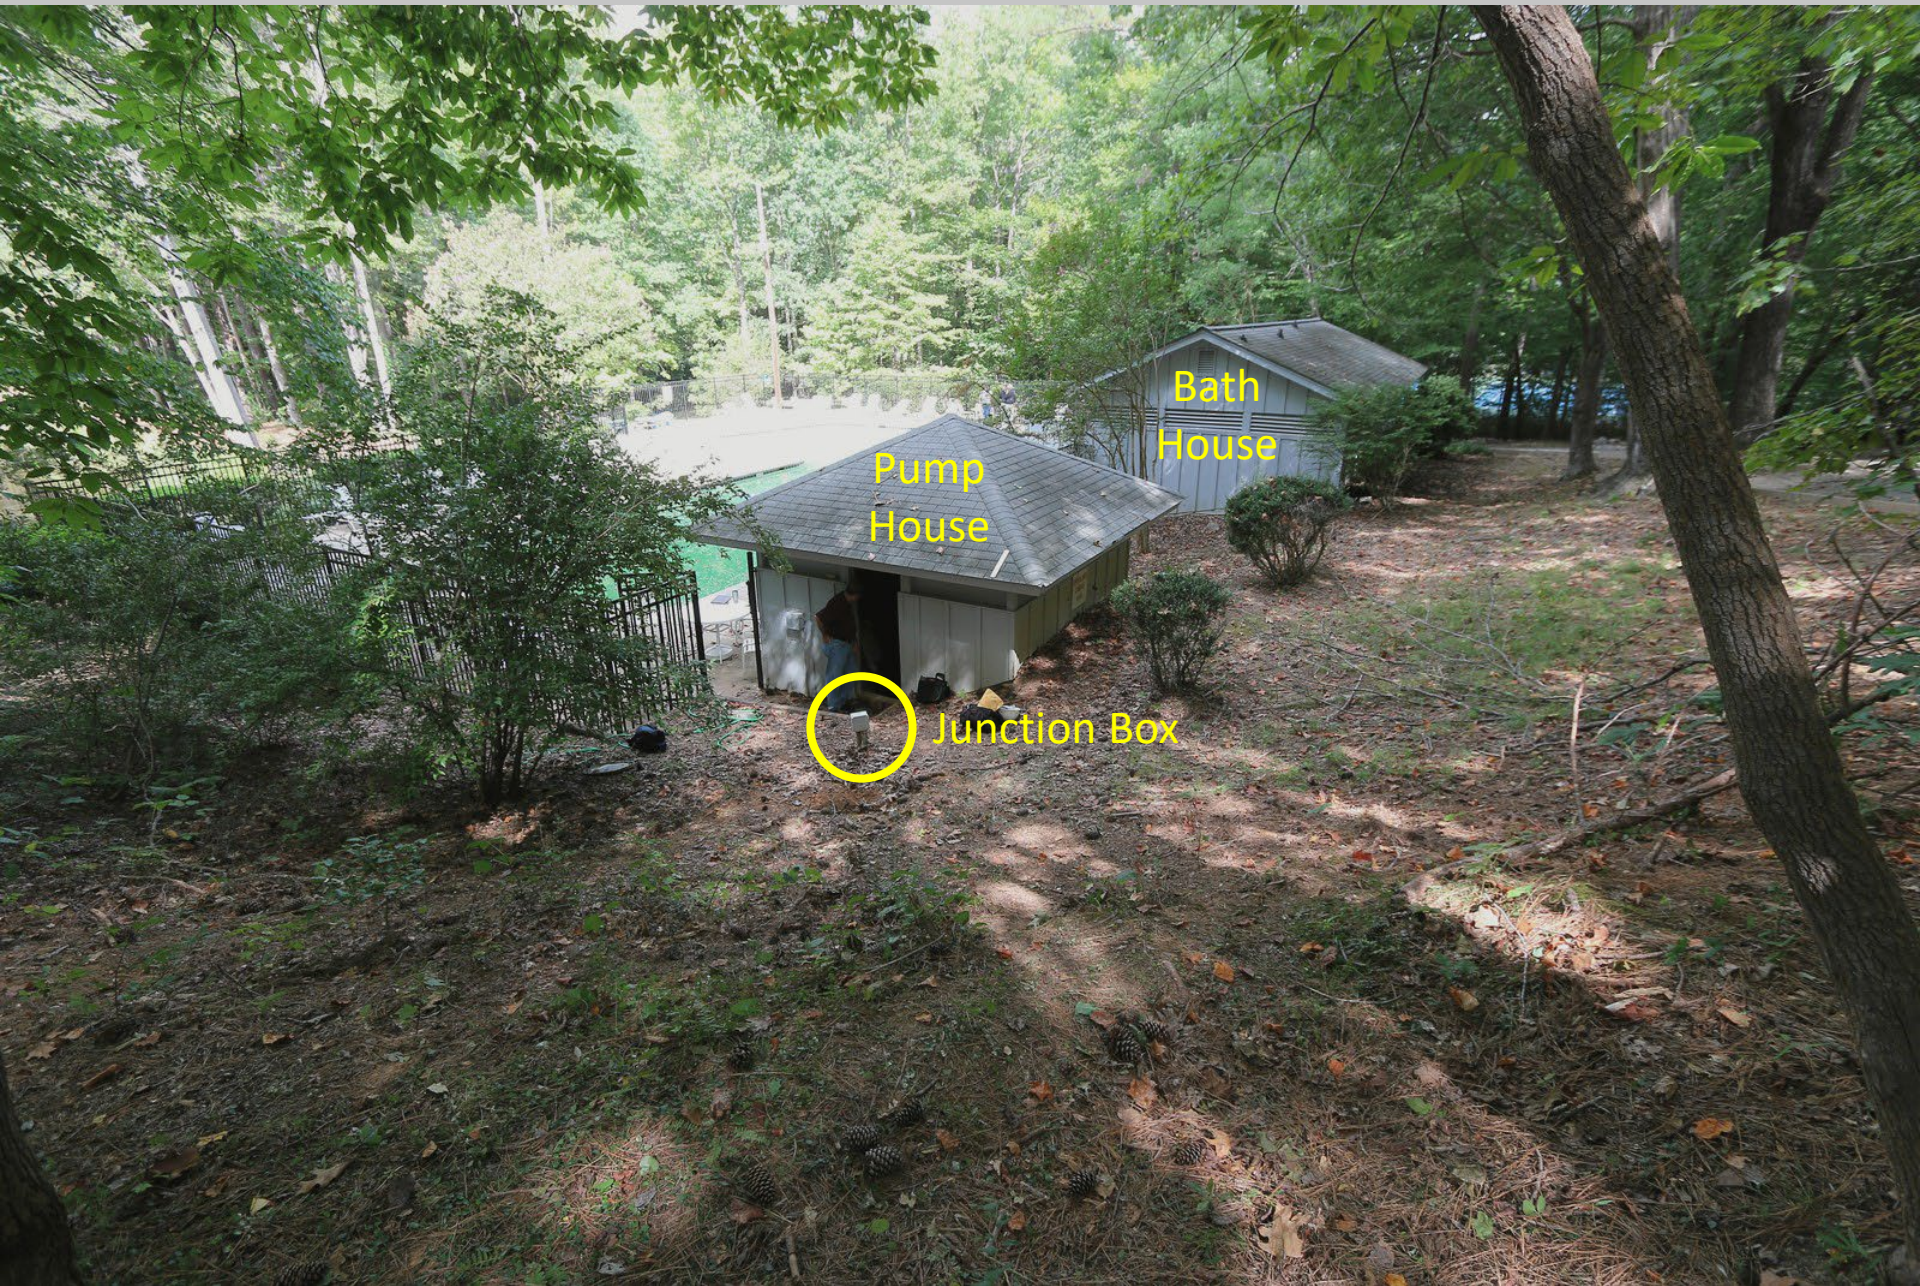
U/2/T1 V/4/T2 W/6/T3

CERUS INDUSTRIAL MIFA MTK-32

TEST TRIP
25 20 15 10 5
OFF ON A H RESET

95-NC-86 97-NO-88

31NC
32NC
44NO
13NO
21NC
32NC
44NO

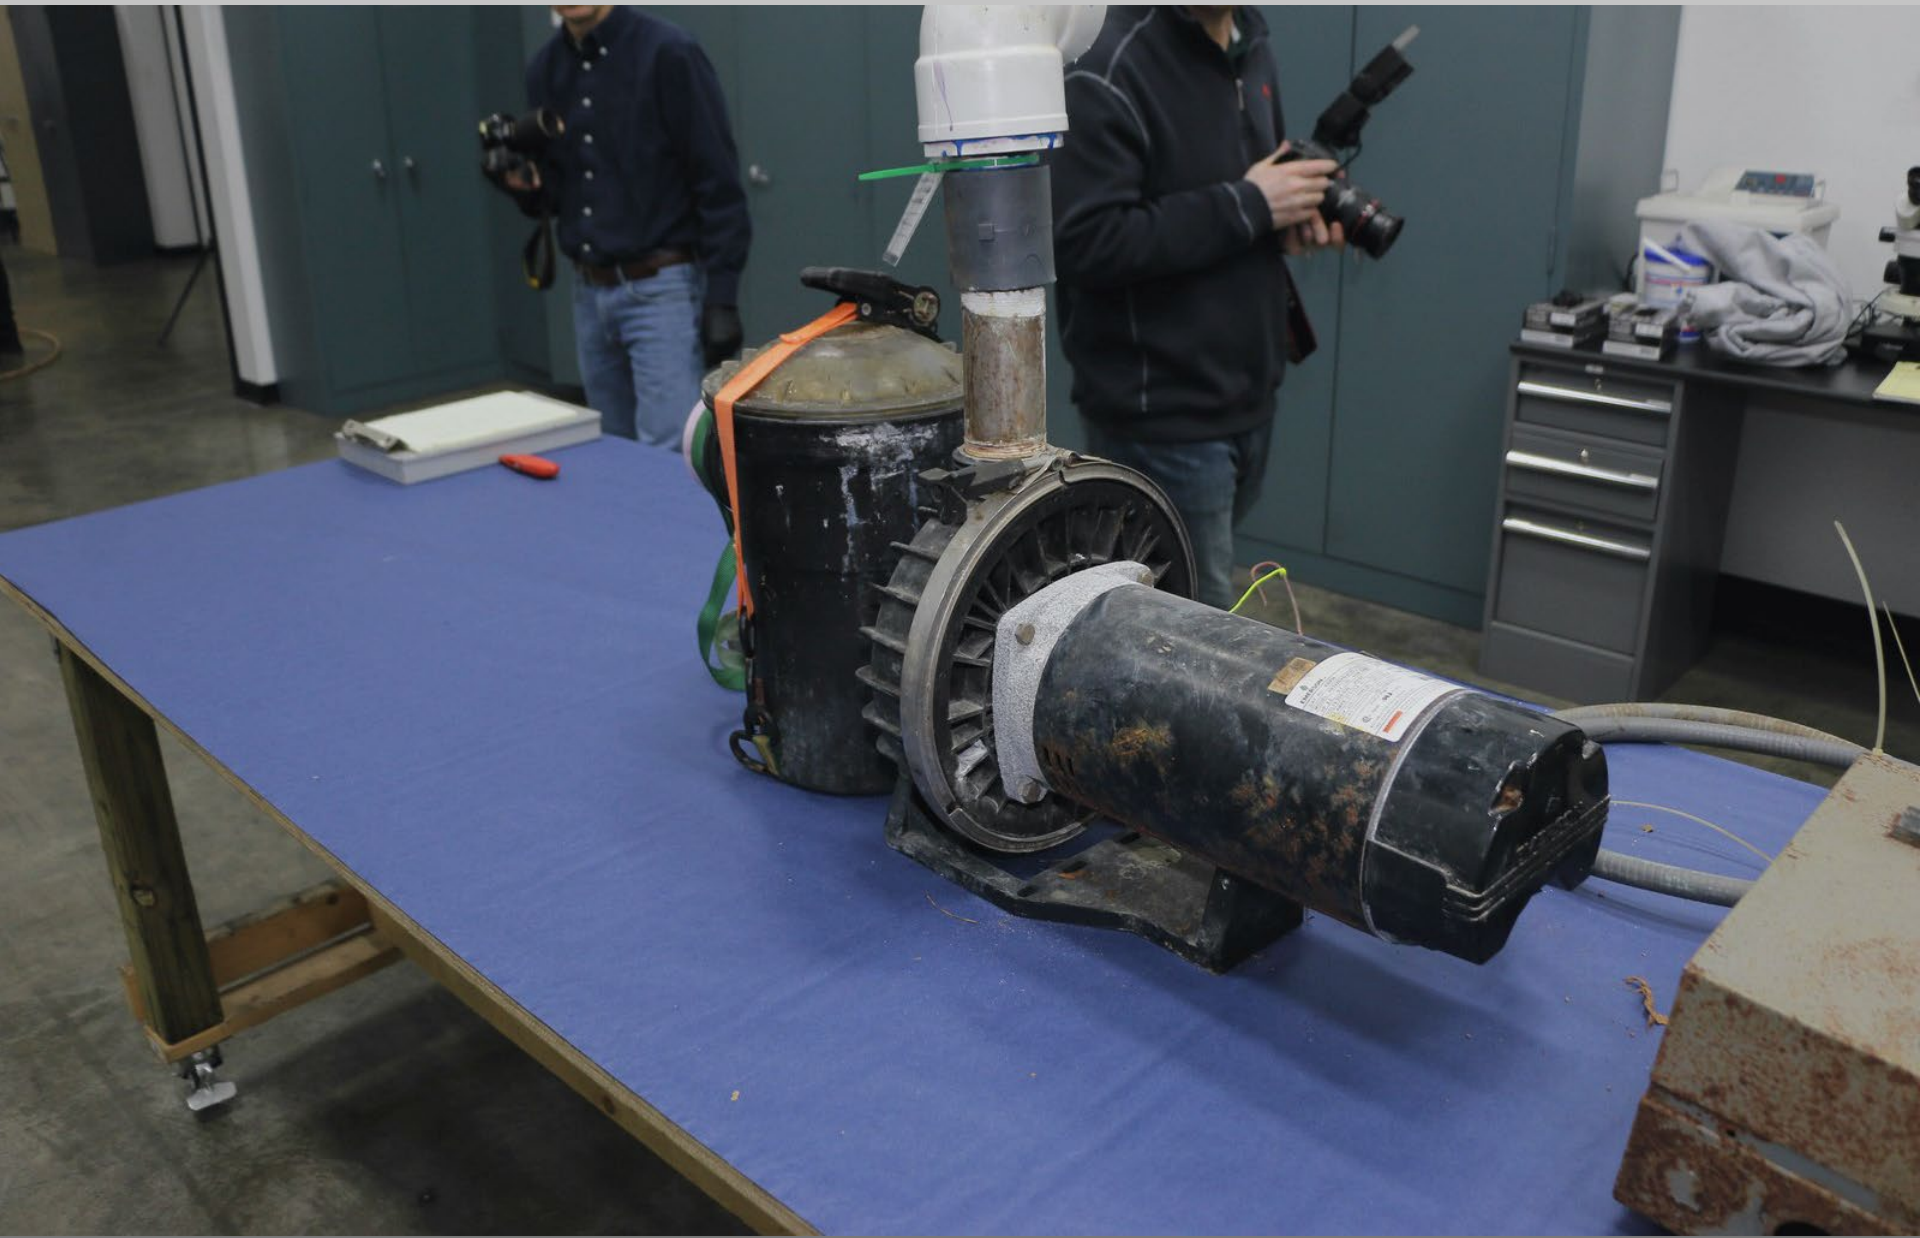
CHALLENGER™
PAC-FAB 5 HP
SANFORD, NC MADE IN U.S.A.
CITY OF INDUSTRY, CA LABEL 35-5460

CFII-N1-5FE
1-17-G97 / 34-5210
SELF PRIMING PUMP
SUITABLE FOR SWIMMING POOLS,
SPAS, OR HOT TUBS.
